# Report

*Project*                    **Odor Migration Concern**

*Location*                    **333 East 14th Street, Unit 6A-N, New York, NY 10003**

*Project  
Number*                    **25499.00**

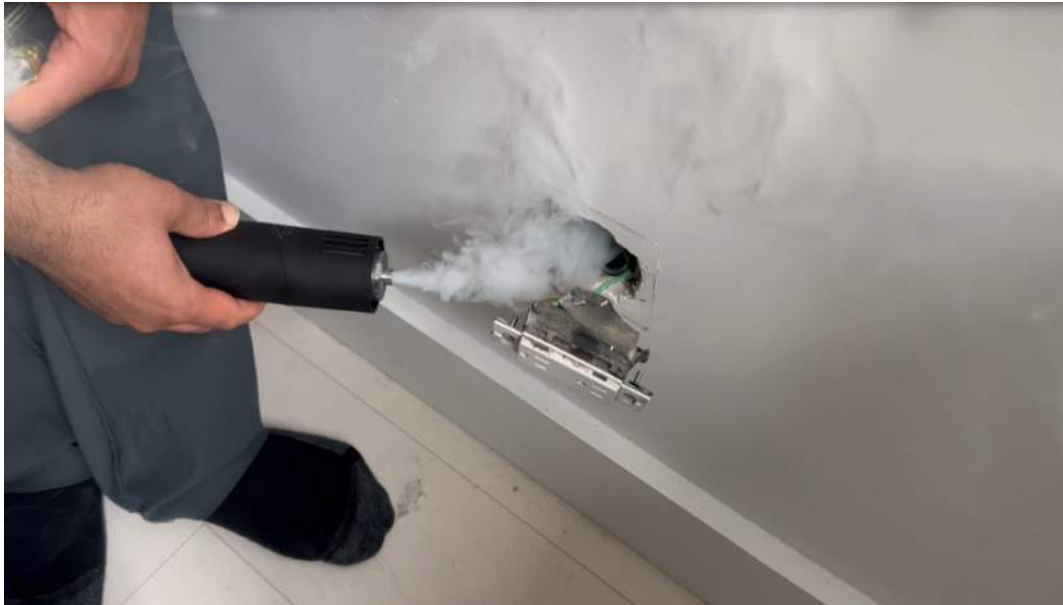
- Electrical outlets in the demising wall were opened to observe smoke movement on both sides. On the Apartment 6B side, smoke was drawn into the wall, while on the Apartment 6A-N side, smoke was seen forcefully blowing out from the outlet opening (refer to accompanying videos).

*Figure 1 Apartment 6B Smoke Exfiltration*

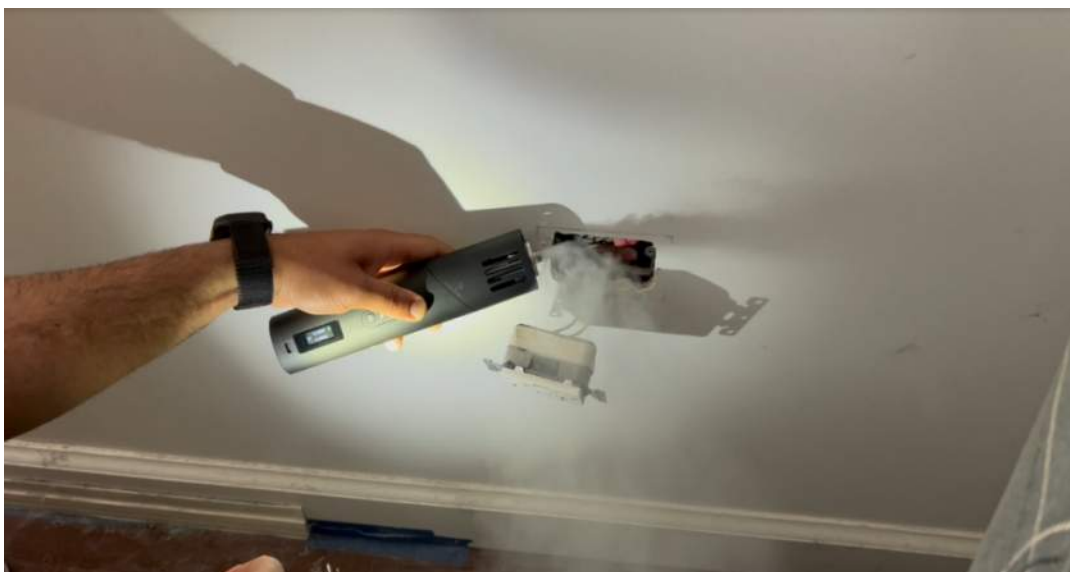
*Figure 2 Apartment 6A-N Smoke Infiltration*

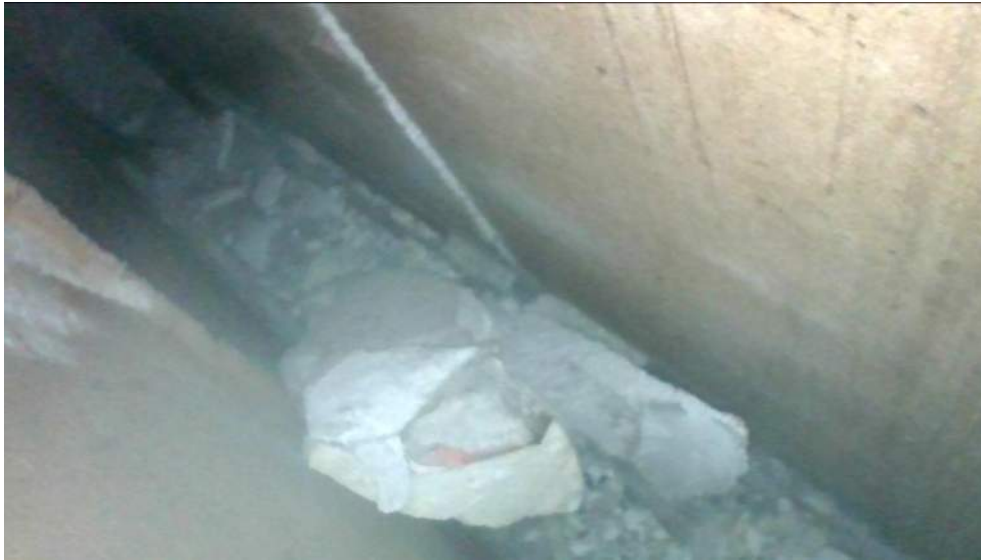
Boreoscope inspection revealed no vapor barrier or insulation between the two units—only metal studs and an empty cavity. Debris was present at the bottom of the wall, likely leftover from construction or possibly from a section of the wall breaking off during or after construction. This debris suggests there may be missing portions of the inner wall or other open sections within the cavity. The debris also made it difficult to fully confirm gaps at the wall base; however, smoke infiltration and visible dust trails indicate that gaps are present.

Figure 3- Demising Wall Borescope

- Completely remove the existing wall between unit 6A-N and unit 6B.
- Reseal and rebuild the wall to eliminate all uncontrolled leakage paths.
- Scope of work should include:
  - Detailed sealing of any and all penetrations with fire-rated sealant or gaskets.
  - Installation of a continuous air and vapor barrier.
  - Installation of sound attenuation matt as specified in the detail for 6A-N renovation drawings.
  - Reinstallation of drywall/plaster finishes to restore a durable, sealed separation between units.

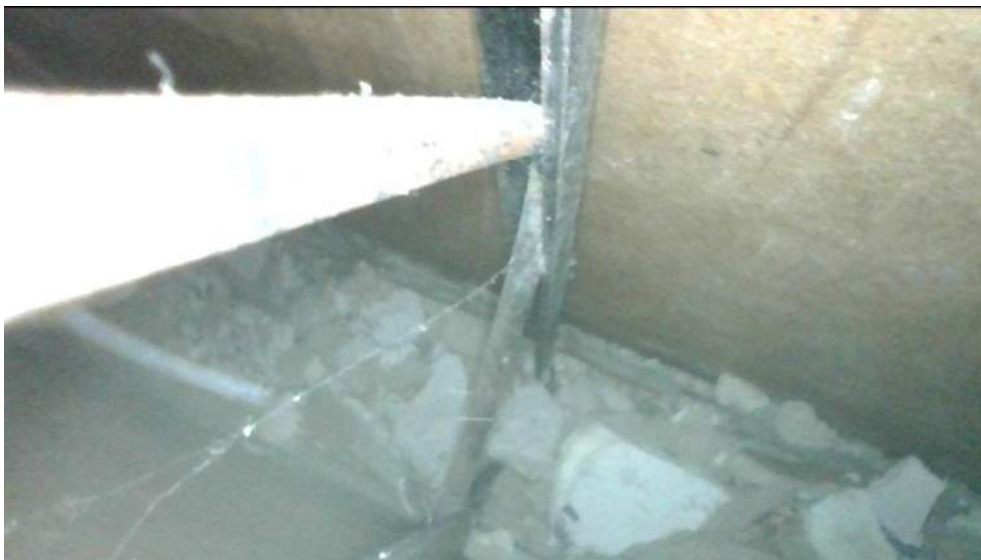
Figure 4 Demising Wall Borescope Image
