OLMSTED ENVIRONMENTAL SERVICES, INC

**Project: Follow-up Indoor Environmental Testing
Odor and Dust Infiltration – Apartment 6NA
333 East 14th Street Apartment 6NA, New York, NY**

Survey Dates March 16th to 23rd, 2026

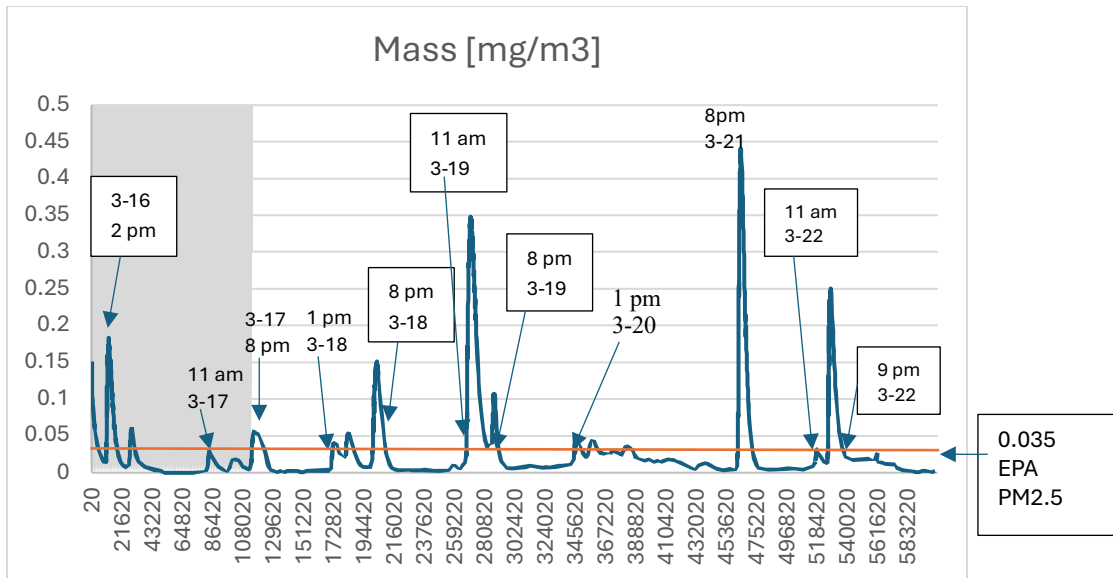
9. Figure 1 provides a scan of the data logged levels over the seven days. There is a pattern consistent with the study completed in January.
 - a. The highest measured level was 0.44 mg/m³. This level is over 12 times the EPA standard for the 24-hour standard of 0.035 mg/m³. It is also well above the outdoor level of PM_{2.5} published by DEP for the 14th street area.

- b. Levels are low throughout the night and early morning consistent with normal background.
 - c. Levels increase late morning or early afternoon and remain higher until around 8 pm. This pattern is repeated most days.

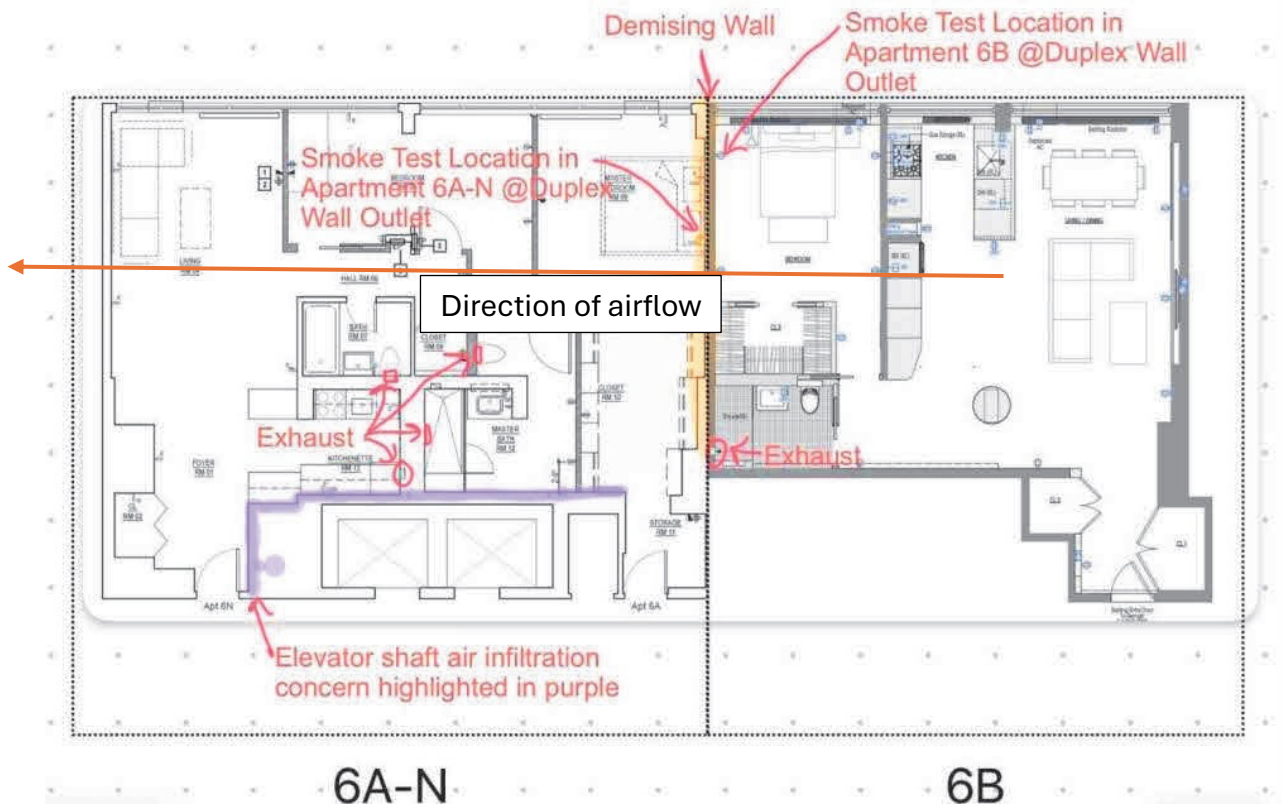
4. Air flowed through the electrical outlet in the living room through the wall shared with the 6B apartment. Apartment 6NA is under negative pressure to 6B and positive pressure to the apartment 6M. The air is flowing through apartment 6NA from 6B to 6N.

5. The attached diagram depicts the directional airflow through 6NA.
6. All four exhausts in the apartment were drawing air. Air flow at the four exhaust grills was estimated by measuring the grill opening size in square feet and the air velocity in feet per minute. The calculated airflow in cubic feet per minute (CFM) are as follows:
